Palmerston Lakes Management Plan

City of Palmerston

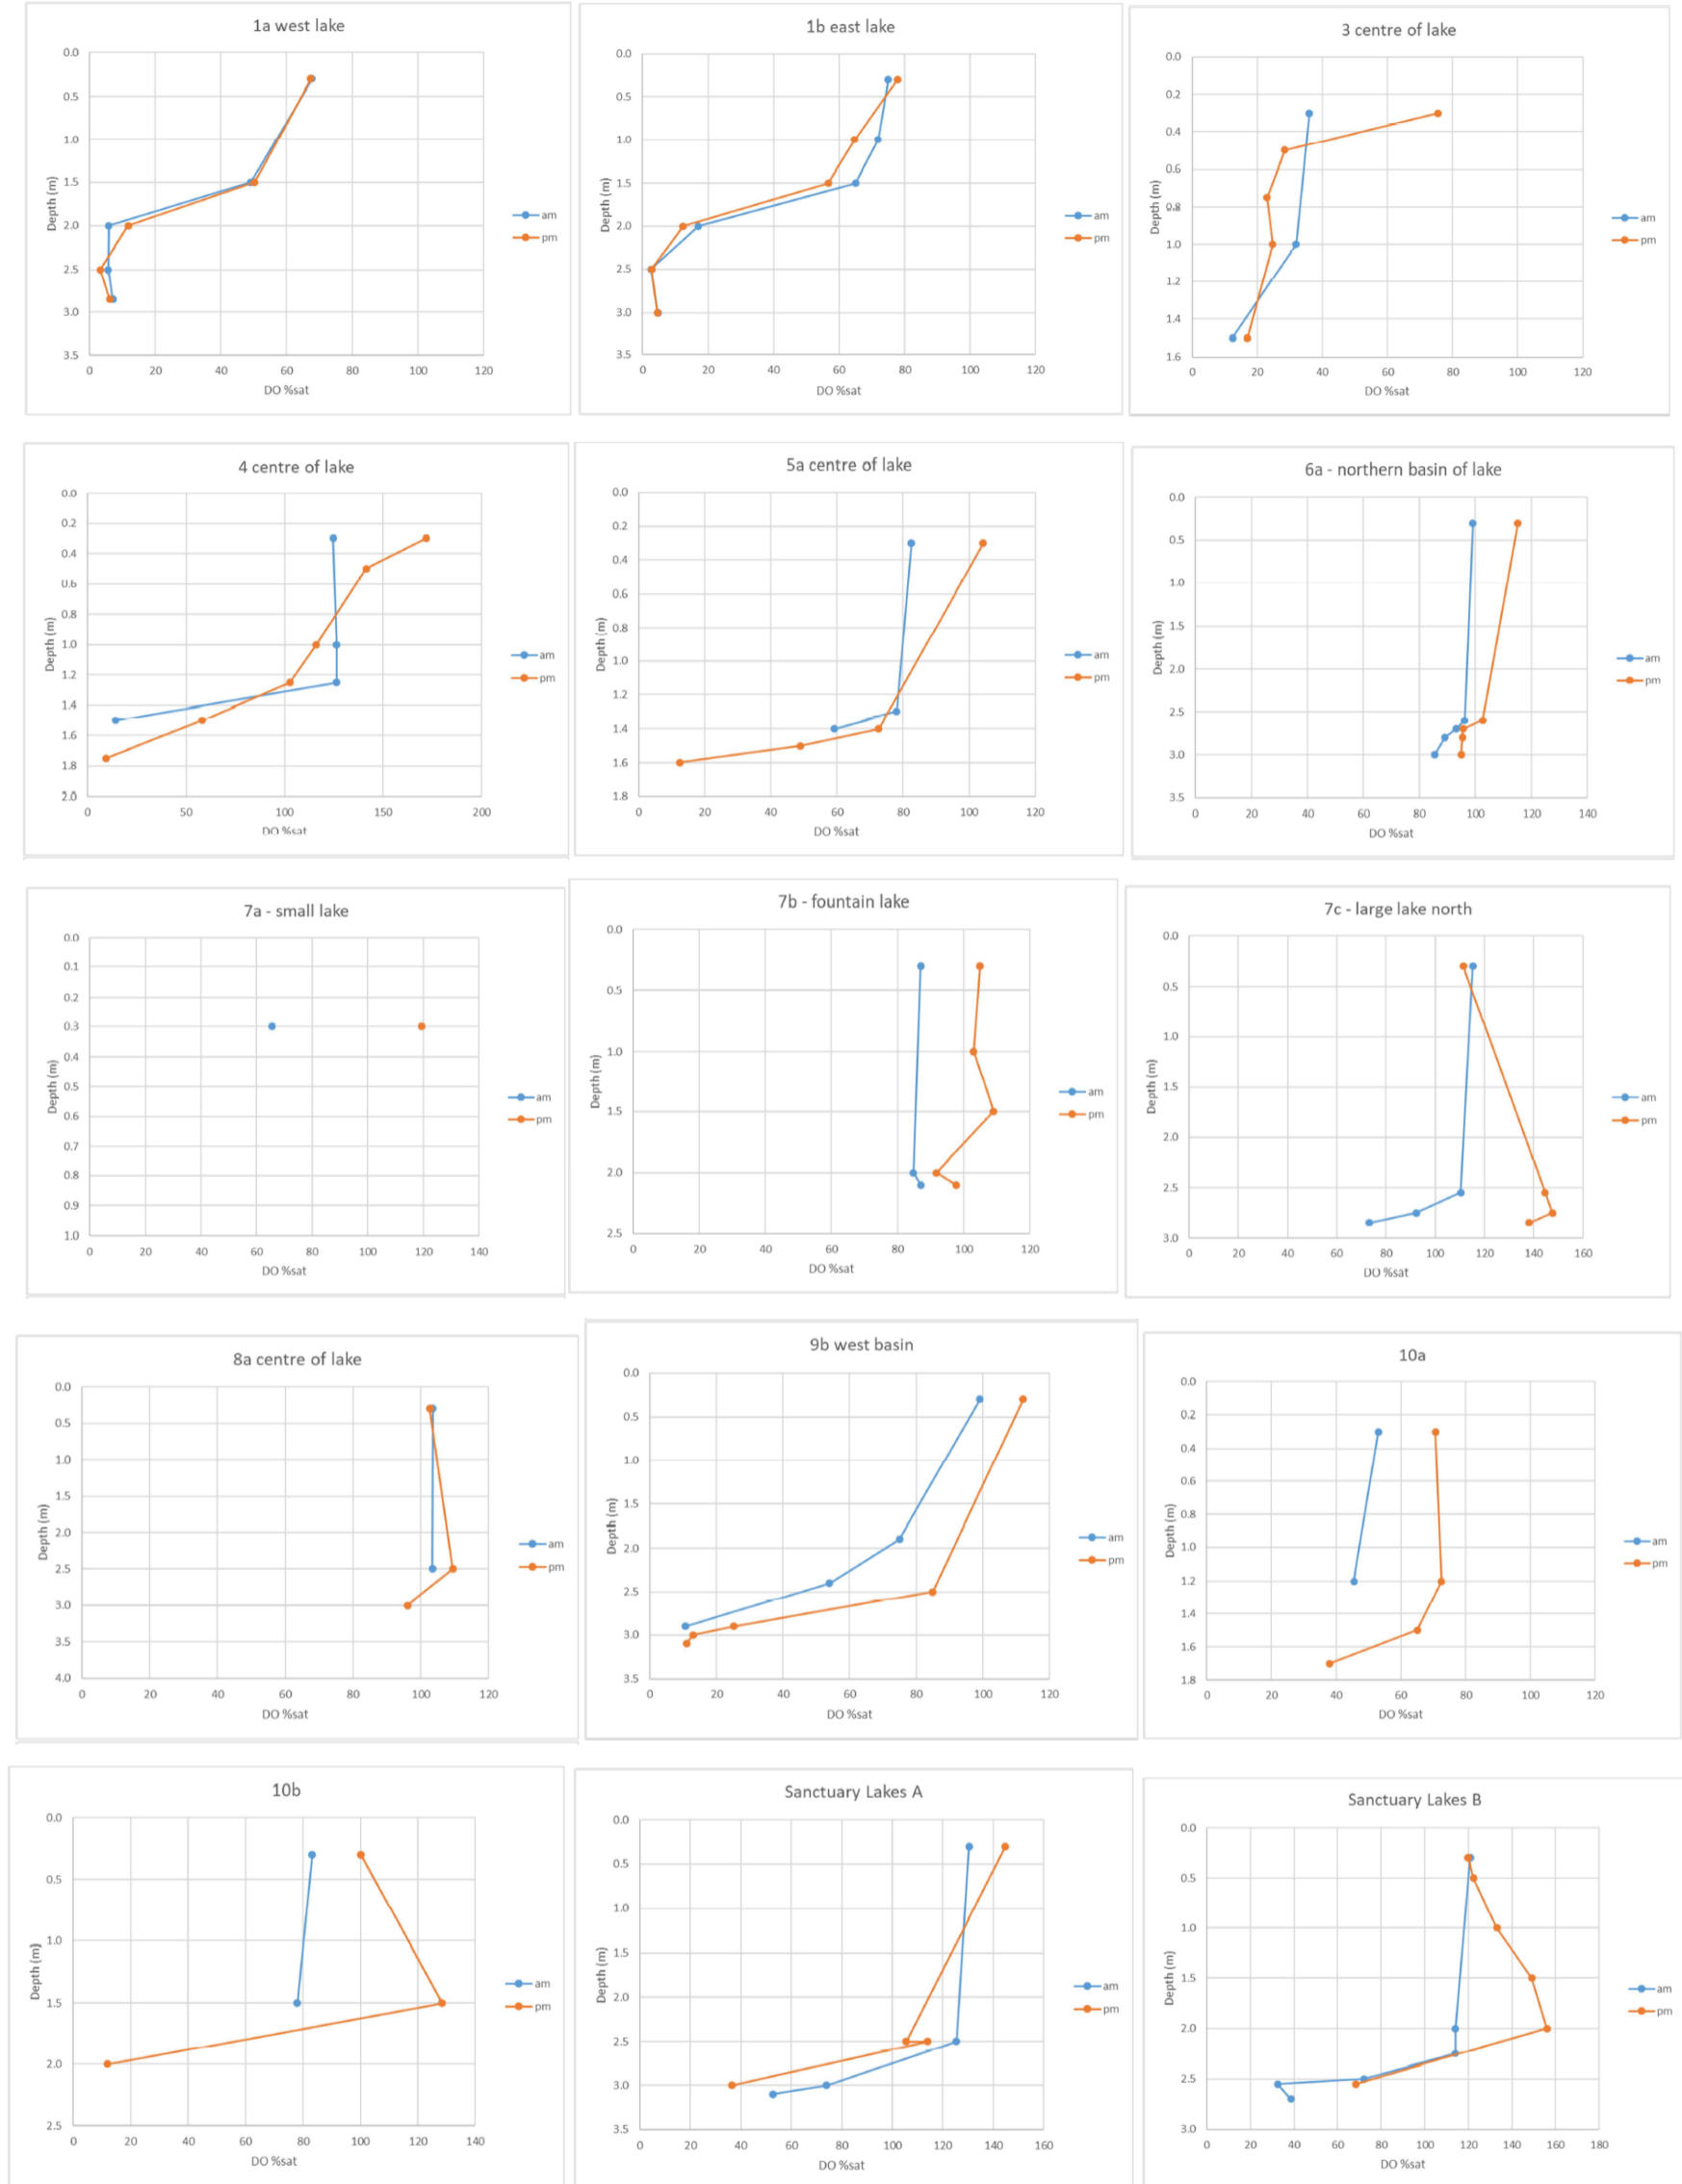
Figure 2-3. Dissolved oxygen in-situ depth profiles. DO survey for Durack Heights was undertaken in the morning; therefore, only morning readings are presented in the graph for this lake.

During each of the morning and afternoon sampling times, DO (and also the other field parameters temperature, pH, EC and turbidity) were measured at the surface and at regular depths throughout the water column. The depth of each site to the lake bottom was also measured using a pole and tape measure. Observations of weather conditions, plant coverage and species, and any other aspects relevant to water quality were noted.

Figure 2-3 presents the DO water column profiles measured at each site during the morning and afternoon. Based on these profiles, the condition of each lake is described in Table 2-3 and given a qualitative rating of “good”, “ok”, “poor” or “very poor”. Sites that were well oxygenated throughout the water column during both the morning and afternoon were assessed as good, whereas sites that had low DO during the morning/afternoon or anywhere within the water column were assessed as ok or poor depending on the degree and extent of hypoxia.

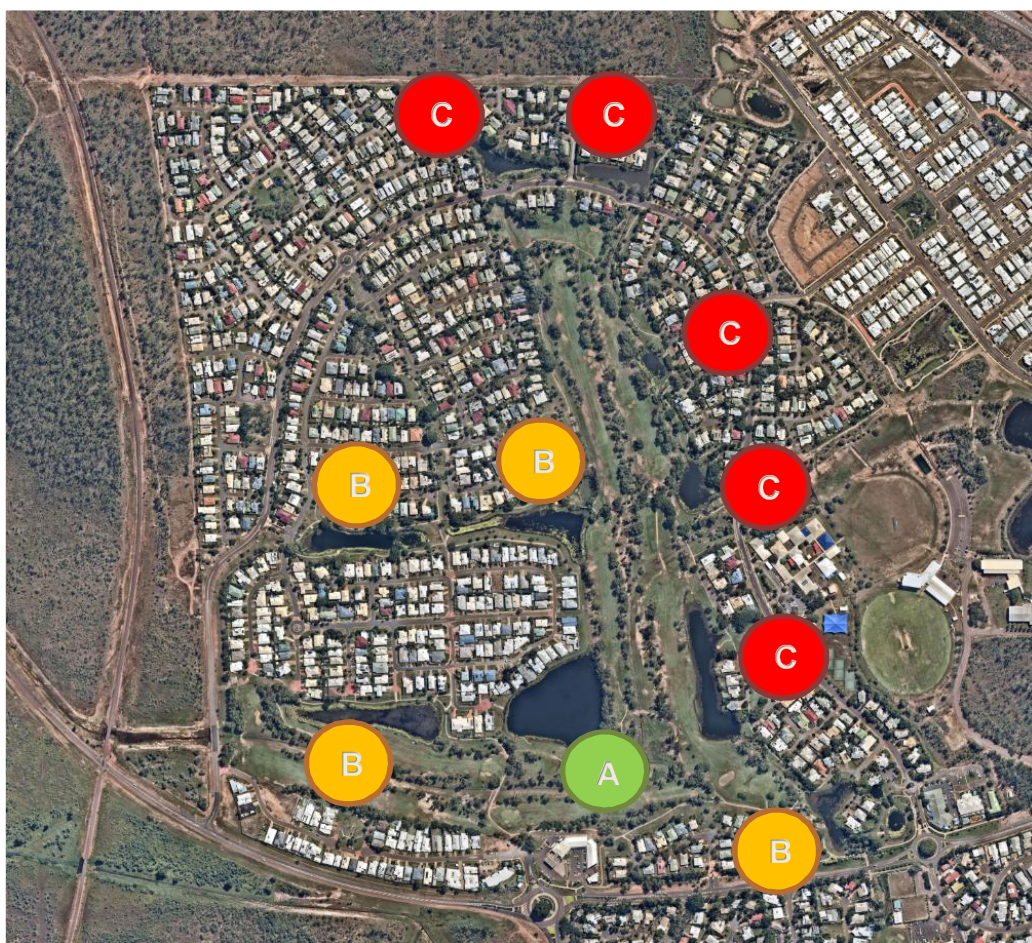
Lake 8 was the standout lake, recording excellent dissolved oxygen concentrations and provided a great habitat for local aquatic wildlife.

Durack Lakes 1a, 1b, 3, 4, and 6 and all three Sanctuary Lakes received a **POOR** rating, due to low dissolved oxygen readings, excessive plant and algae growth, as well as large amounts of *Salvinia molesta* (Salvinia), a Weed of National Significance.
